- for Liftreport and our customers -	<b>Technical Customer Information</b>	<b>KI0204e0</b>
	<b>Occurrence and avoidance of damage to elevator motor windings during inspections</b>	2002-2008 page: 1 of 4

## Mechatronics for elevator installers and drive technicians, part 11 14

Dipl. Ing. Götz Benczek, Swetlana Wahnsiedler (Emotron Lift Center GmbH)

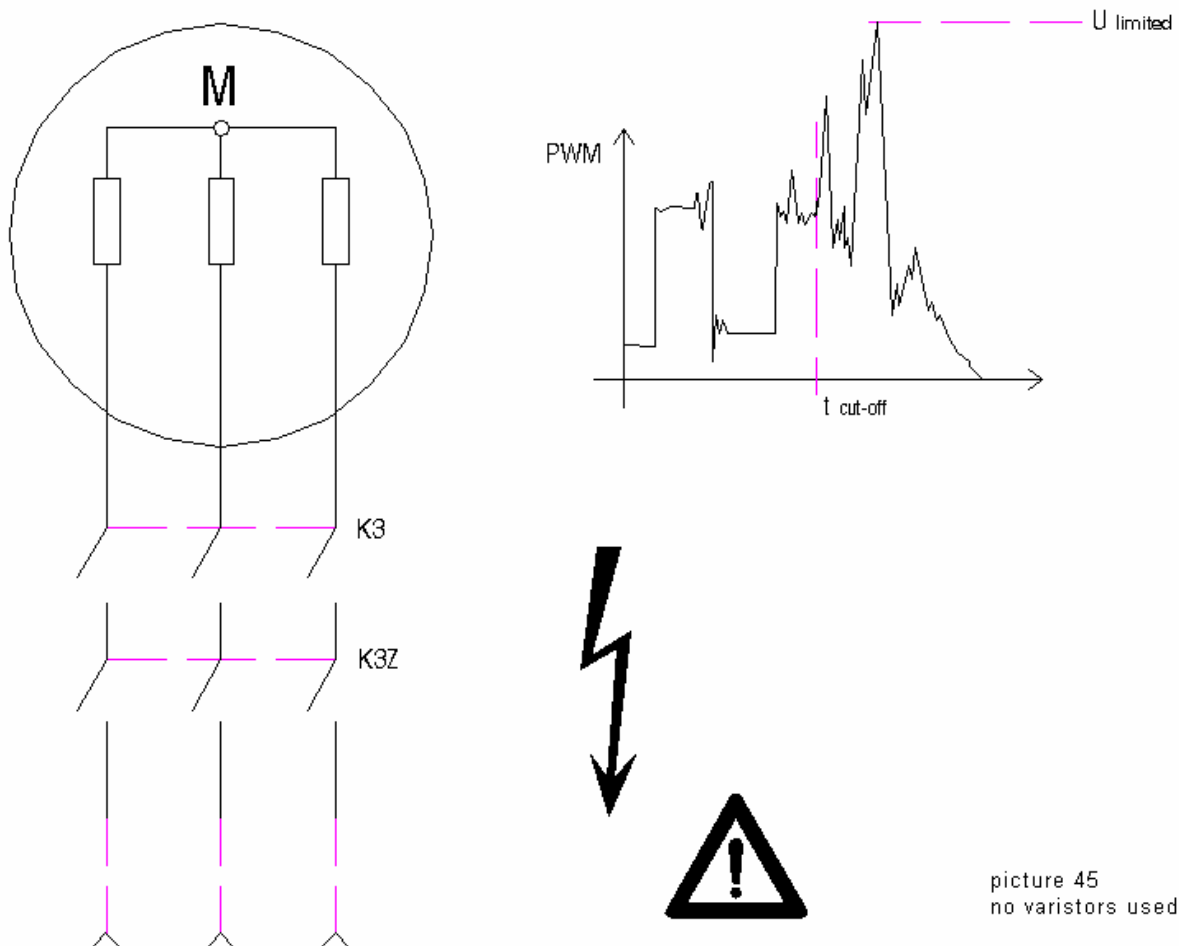
picture 45  
no varistors used

We see here that, over a period of several milliseconds, voltages up to 10kV can occur, at a  $dU/dt$  ratio of as much as  $10kV/\mu s$ . Situations such as this can damage the motor's windings over the long term. This may be aggravated by pre-existing damages resulting from excessive winding heating and/or high impulse frequencies without the appropriate  $dU/dt$  protection. The service life of the motor's windings is thus shortened considerably if such voltage peaks occur frequently (and this is regrettably the case during inspection operations).

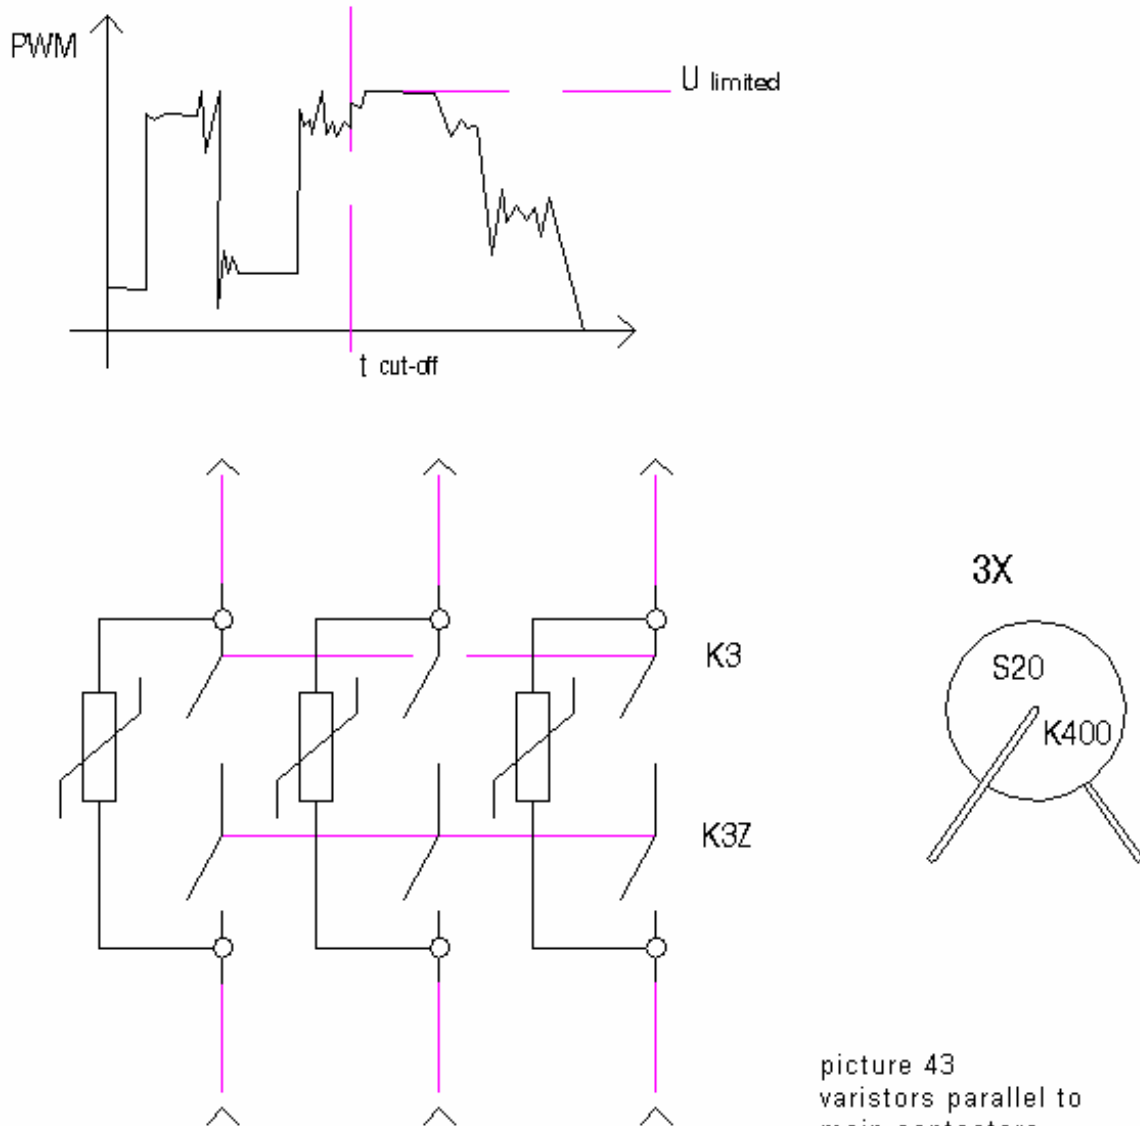
picture 43  
varistors parallel to  
main contactors

There are three different ways to avoid this effect. The first is shown in **picture 43**, though it should be noted here that this circuitry concept is not permissible for passenger elevators since "positive disconnection" does not actually exist. This circuitry is nonetheless very effective and very simple. The voltage is returned through the varistors to the free-wheeling diodes at the inverter and is thus reduced in an effective fashion.

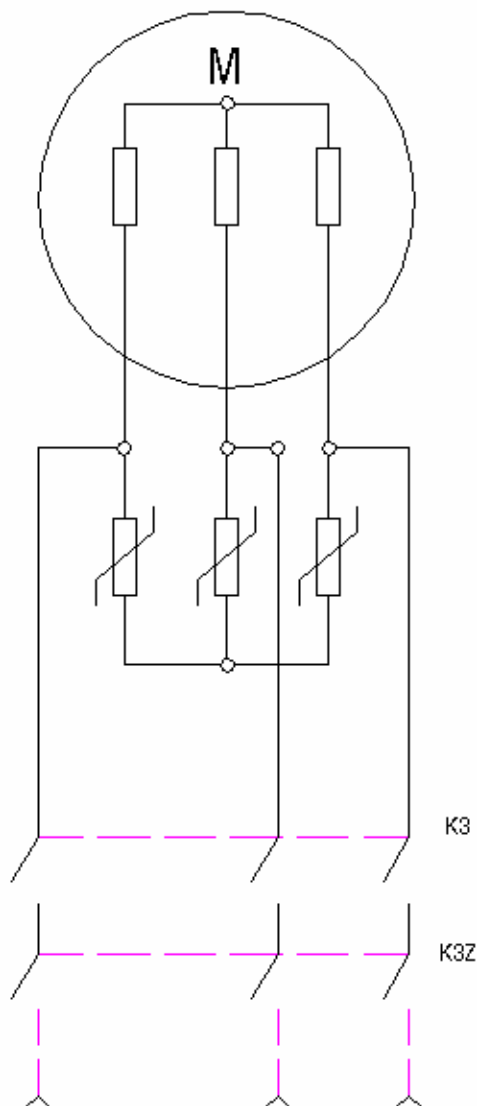
picture 44  
varistors parallel  
to motor coils

Since the option shown in **picture 43** is not always permissible, only the second alternative can, as a rule, be considered. Here the varistors are mounted directly at the motor's winding. We see in **picture 44** how the three varistors are connected to the motor terminals. The varistors carry very high voltages and are, in addition, arranged in a "star" configuration. The reason is to maintain the greatest possible clearance to the excess voltages which naturally occur as a phenomenon concomitant to pulse width modulation. The circuit shown here is suitable for use with a typical 400-volt network, where peaks up to 2kV may occur. A "modern" winding should in any case be able to withstand as much as 4kV. There should be no problems with the notified bodies in regard to the circuit shown below, but we should nonetheless discuss a third option in which the problem does not arise at all.

The concept which uses the "STOP" button in conjunction with the varistor circuitry, as shown in **picture 44**, not only offers ideal protection for the motor and mechanical components, but also makes for convenient operation during inspection. Interrupting the safety circuit will no longer result in unacceptable loading at the relay contacts, motor windings and inverter and at the same time – and as an extra benefit - suppresses the popping interference generated when the contacts open.
