-for Liftreport and our customers-	<b>Technical Customer Information</b>	KI0111e0
	<b>Mechanical causes for poor travel characteristics</b>	2002-2008
		page 1 of 4

## Mechatronics for elevator installers and drive technicians, part 10

### 1 Deflection pulley and drive sheaves as the causes for poor travel characteristics

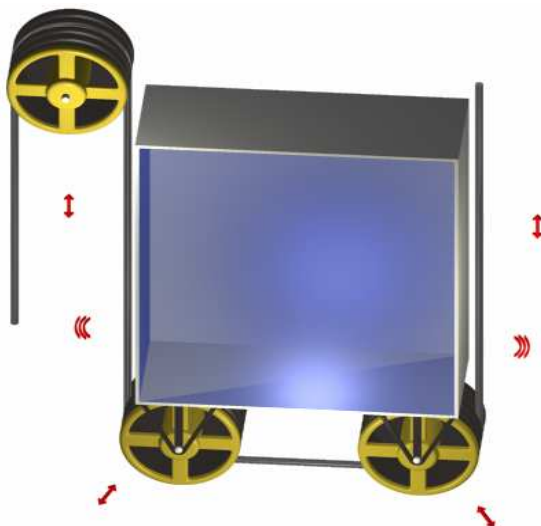
**Figure 31**

Elevator systems sometimes provide unpleasant surprises in practice in the form of very poor travel properties. Even though newer installations which are comparable in design may incorporate the latest in drive technology, many older elevators offer distinctly more comfort. The reasons for this many and varied and in most cases will be found in an unfortunate combination of several factors. Nowadays we first check the system's electrical and/or electronic components whenever elevator travel proves to be unsatisfactory. Consequently, a later article will discuss in detail programming and parameterization for the electric drive. We will assume for the purposes of the present article that the drive system (in this case the motor and frequency inverter) has been adjusted correctly and that the interface to the external elevator controls is working perfectly. And in spite of this we find that the customer complains of oscillations and rumbling in the car, for example. There is no obvious explanation for this phenomenon. Measurements carried out with structural noise detection instruments reveal frequencies which are a function of travel speed. Often these are very low frequencies of 5 Hz and less. If we look more closely at the mechanics of the elevator, then we quickly discover the reason: The deflection pulleys are the most frequent cause of „hopping“ cars and undefined vibrations. In most cases deflection pulleys are cast parts (e.g. a gray casting or plastic material). CNC machines (turning, milling, grinding, etc.) are used to impart the final dimensions and finish. In the interest of cost reduction the tool feed speeds are set quite high at these fully automatic units so that as much material as possible is removed within a short period of time. These high advancing speeds require, in turn, excessive chucking pressure. The forces exerted by the chuck and when advancing the tool tend to deform the work piece. A pulley manufactured in this way is no longer perfectly round and will inevitably induce vibrations (several periods per revolution). The vibrations are transmitted to the car through the ropes and generate a characteristic rumbling in the car (Figure 31).

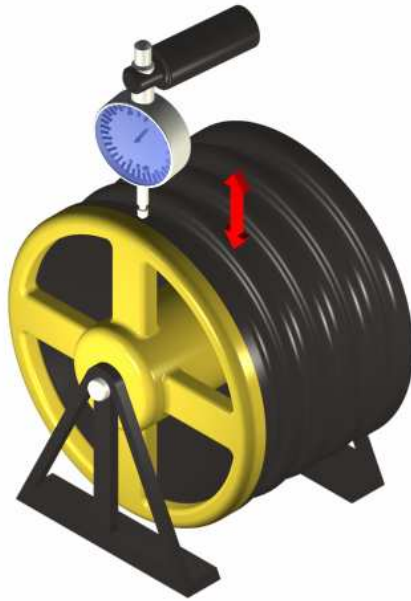
**Figure 32**

Equally unpleasant are those oscillations and vibrations occurring in a range of, for example, just 1 to 2 Hz. If here, once again, oscillation frequency rises proportionally to the elevator's travel speed, then the cause may be radial run-out at the deflection pulley (Figure 32).

The reason for such phenomena at the pulley is improper machining (and most assuredly working the material too fast) on the one hand and failure to observe the resting periods prescribed for the raw material. (Before being machined, castings have to rest for a certain period of time during which internal stresses and strains can dissipate.) Quality control inspectors will not recognize at first glance that poor quality materials or poor machining techniques have been used. Here is a helpful hint: mount the pulley so that it can rotate freely on a shaft. Measure the radial and axial run-out; good pulleys and sheaves exhibit accuracy of  $\pm 0.01$  mm (measured at the flanks of the groove). Values exceeding  $\pm 0.03$  mm need not be accepted. Return such goods to the manufacturer; your elevator owner will be grateful.

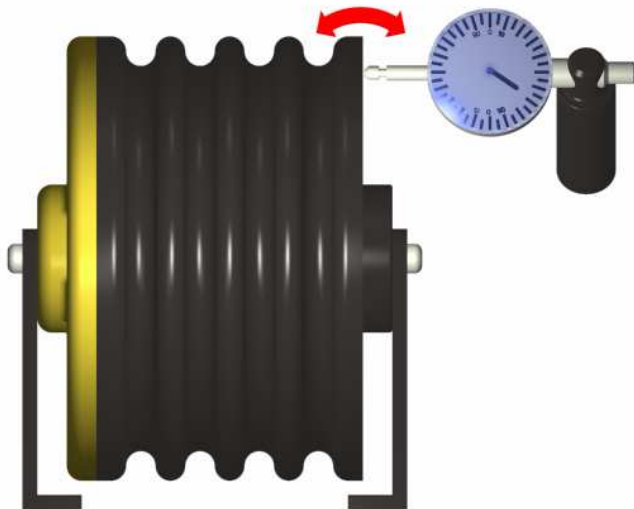
**Figure 33**

In some cases this is further aggravated by axial run-out and oscillations of the type just described are then joined by noise, since the ropes may very well vibrate the strings on a musical instrument (Figure 33).

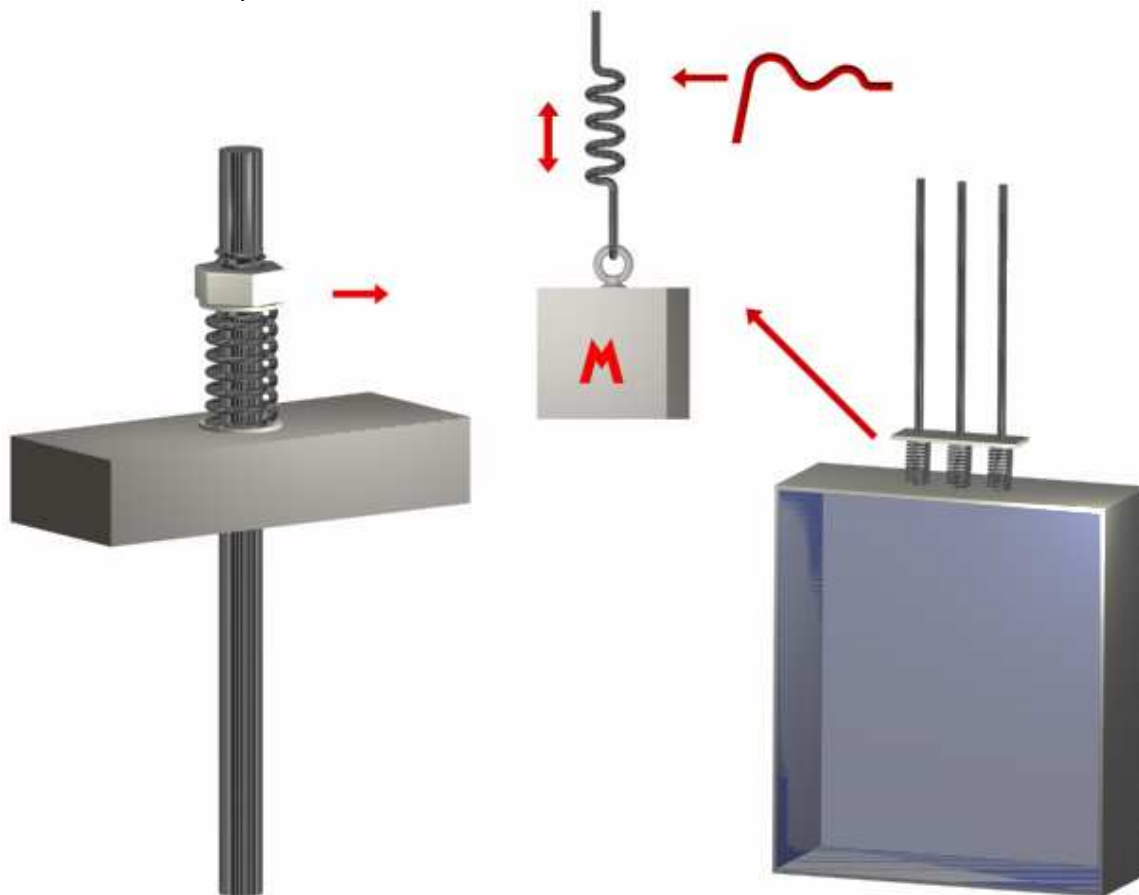
**Figure 34**

Once you have examined the pulleys and drive sheave (and replaced them, if indicated), the lift should run perfectly without any vibration or rumbling. If in spite of all this discernible vibration continues to be present in the car and, in addition, this vibration does not seem to be directly related to travel speed, then we are dealing with resonance at a sprung mass. As a rule this will be an actual physical spring which is used either to equalize the loads on individual ropes or to implement mechanical load measurement (Figure 34). In the worst case this may induce resonance in the elevator system, which then results in unpleasant oscillations.

It is usually possible to suppress oscillations in such cases by changing out the spring (e.g. replacing it with one exhibiting „harder“ response properties) and thus shifting the resonance point. Load measurement systems based on detecting linear displacement in a sprung system should no longer be used at all. Good electronic systems employ strain gauges which are, for example, integrated into the cable clamps, thus doing away with sprung systems entirely.

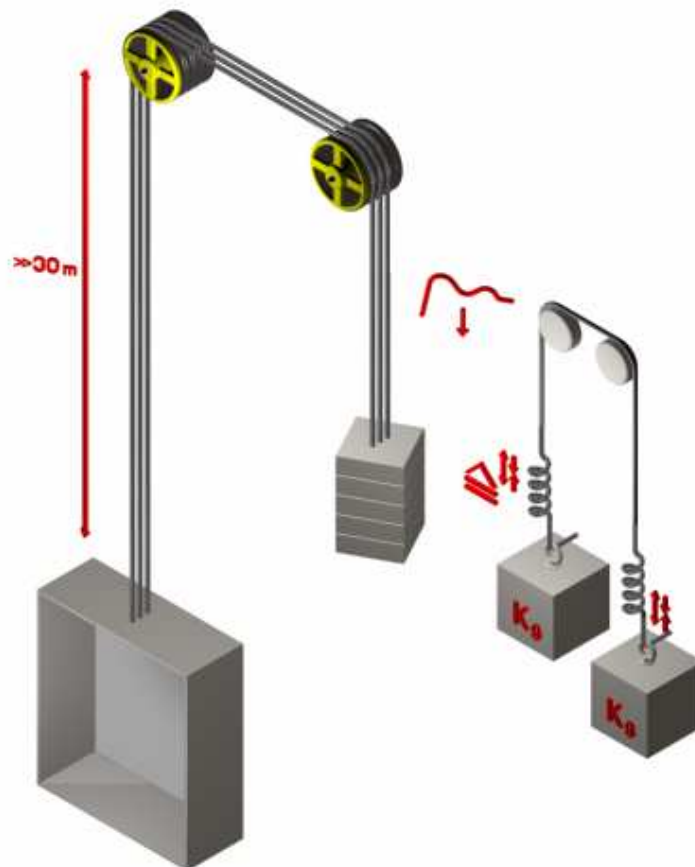
**Figure 35**

Very long ropes act like rubber bands (Figure 35). Further aggravating the situation is the fact that wide temperature fluctuations will also have a major effect on rope resonance. In addition, the importance of selecting the car's weight and the rope design correctly should not be underestimated.

Where vacant grooves are available at the sheave improvements may in some cases be achieved by installing additional ropes. The best approach, however, is to try out a different rope design. Something which was standard practice in the past which is seldom seen today is installing ropes with alternating directions of twist. This will neutralize any tendency to a preferred direction of torsion and rotation, making more uniform the loading on the rope drives.
